SHELBURNE FALLS ROAD SAFETY STUDY

TCE# 2012005-1
HINESBURG, VERMONT

Date:
September 29, 2014

Prepared For:
Town of Hinesburg

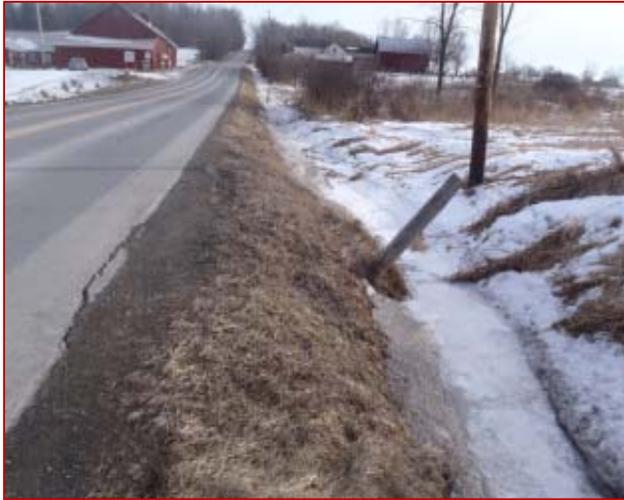
Observation: Deteriorated culvert backfill, with steep drop-off from edge of road in both the eastbound and westbound directions, and poor drainage and steep slopes in Westbound approach towards culvert across from Crow Hill Road. Poor surface drainage is causing scouring along the westbound shoulder resulting in degradation of the surface course.

Figure 1: Steep slopes near deteriorated culvert backfill

- **Mid to Long Term:** Replace the 12" CMP driveway culvert under the drive 300' West of Crow Hill Rd. accessing the EB lane of the corridor with a State minimum 15" HDPE culvert, improving conveyance of runoff and minimizing ponding on the traveled corridor. Extend the drainage ditch along the side of the WB lane between mm .5 and .575 to connect existing drainage ditch with existing Stormwater detention pond. Construct minimum 15" HDPE culvert under the dual driveway.

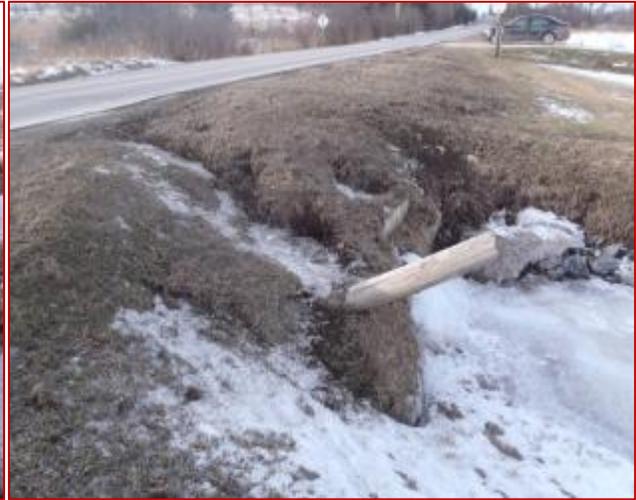
Figure 2: Steep slopes and deteriorated culvert backfill

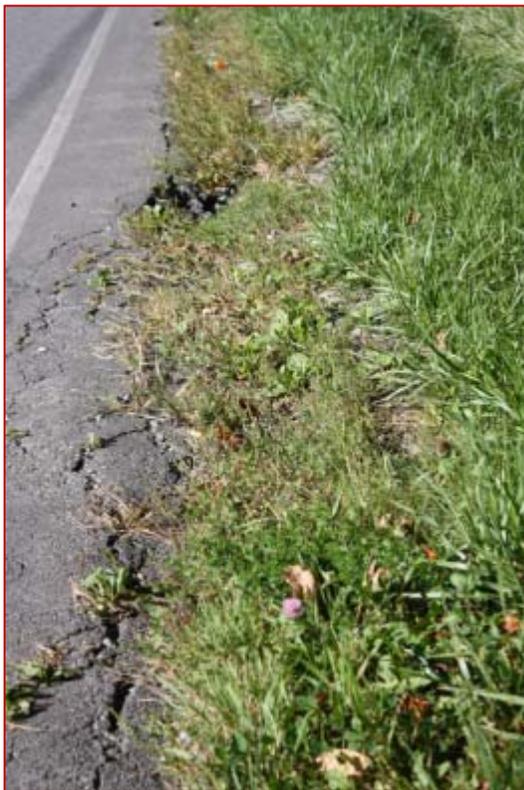
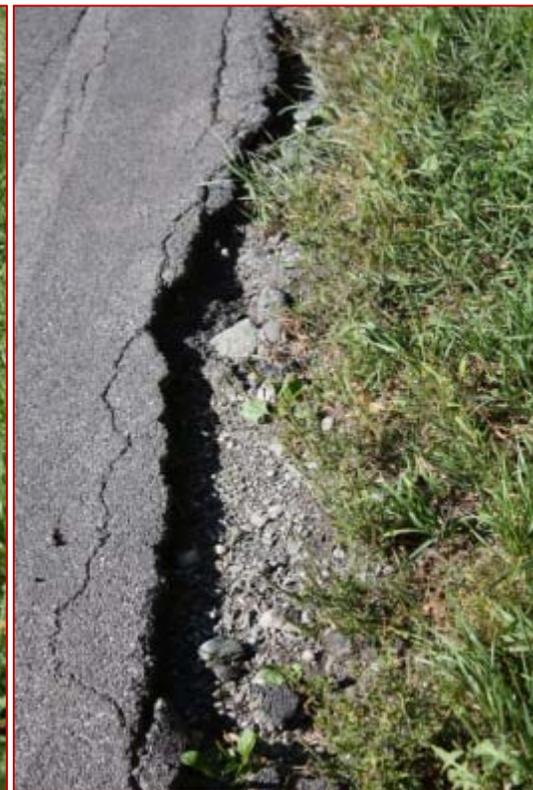
Figure 3: Shoulder degradation across from Crow Hill Rd. WB - September 2012

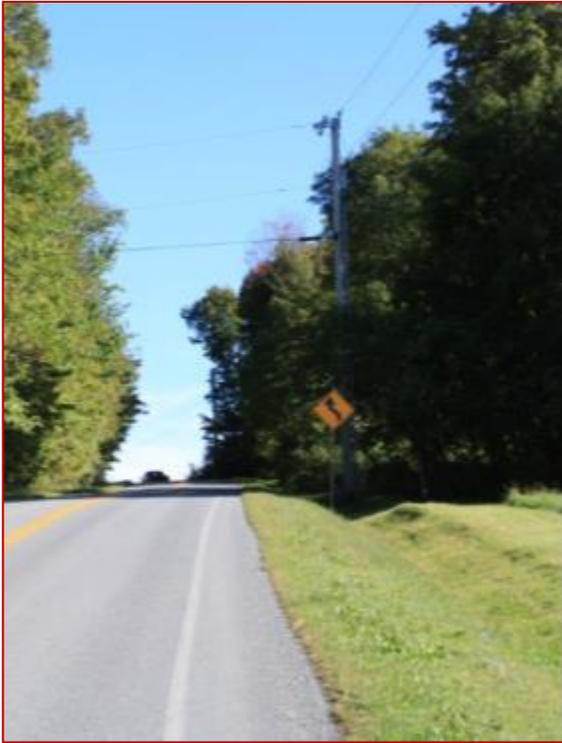
Eastbound traffic is warned with a reverse curve sign (W1-4L) before the steep uphill approach towards the driveway intersection and a left curve sign which is subject to blockage from nearby vegetation (W1-2L).

*Figure 4: Reverse Curve Sign
EB – September 2012*

- **Immediate Action:** Erect 25 mph advisory speed placards (W13-1P) to the existing advance warning signs. See Proposed Sign Map Sheet 1 in Appendix 5. Replace the broken reverse curve warning sign for WB traffic. Clear vegetation that is obstructing the view of signs and sight distance throughout this section of the corridor.
- **Short-Term Action:** Consider lowering speed limit to 35 mph for this stretch of corridor. Erect a reduced speed ahead sign (W3-5/W3-5a) followed by a speed

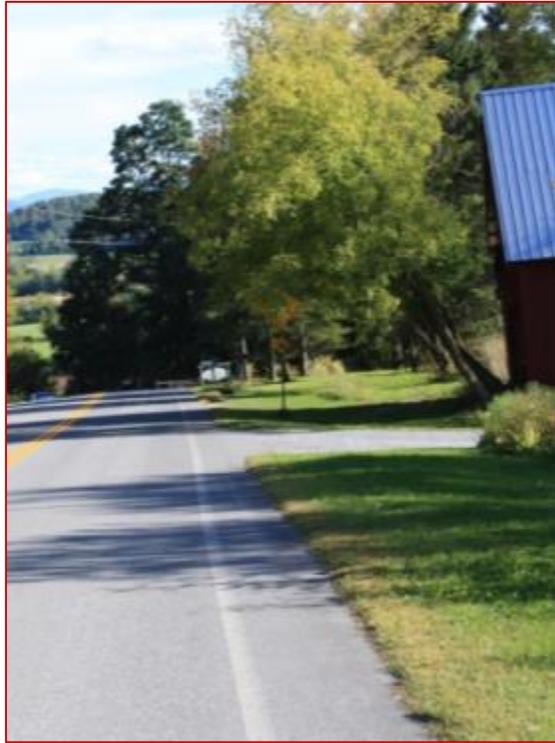
*Figure 5: Left Curve Sign
EB – September 2012*

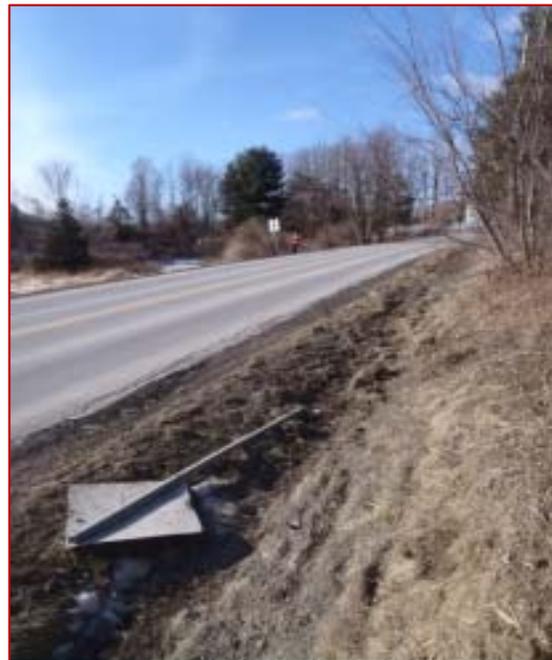
Westbound traffic is warned of this potentially hazardous stretch of road with a reverse curve sign, which was broken and lying horizontally on the side of the road during the site reconnaissance in February of 2014. Tire tracks leading up to the sign suggested evidence the sign was broken during a crash.

*Figure 6: Fallen reverse curve sign
WB – February 2014*

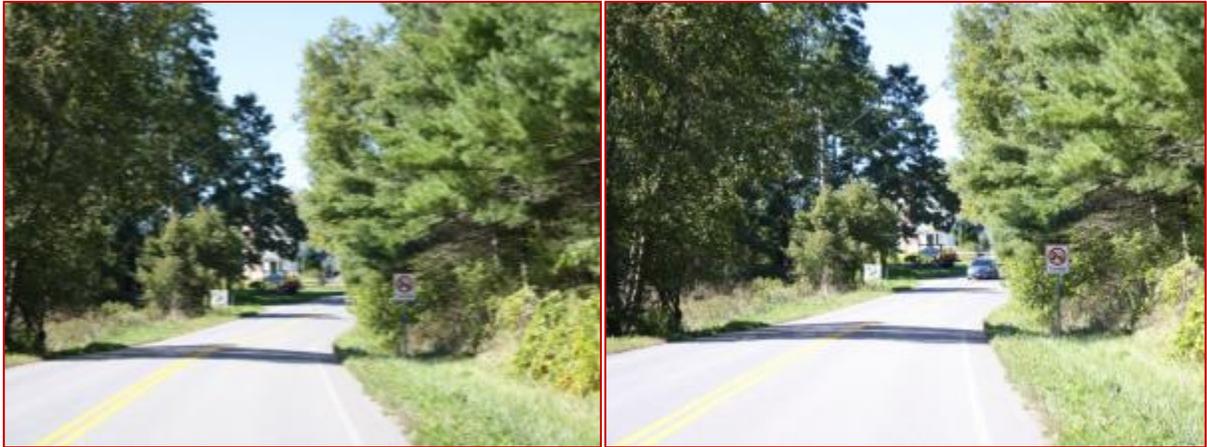
Sight distance measurements from intersections, driveways, within this section of corridor, indicated lower than recommended sight distance for the posted speed. Horizontal and vertical curves and overgrown vegetation reduce visibility for both EB and WB traffic. There is a recommended corner clearance of 230' for intersections

Figure 7: View for Westbound traffic approaching Boutin Rd. Intersection WB – September 2012

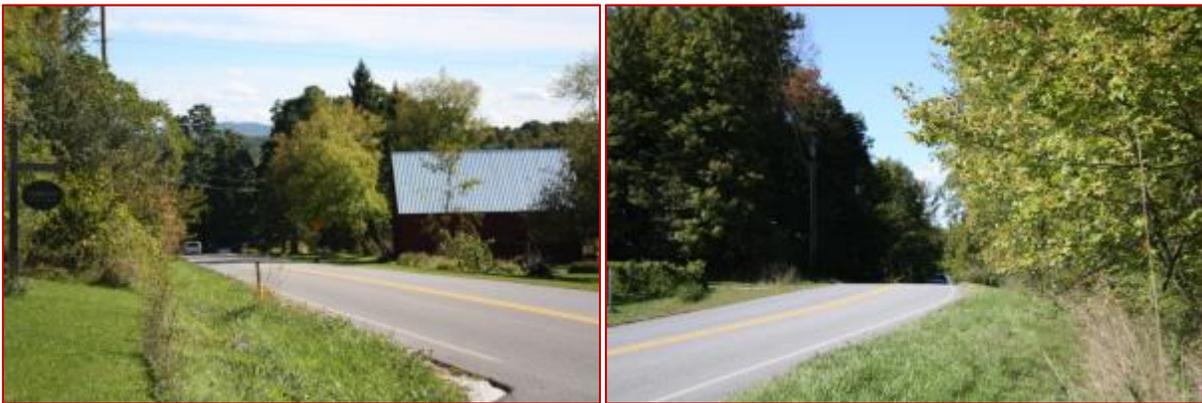
There is a recommended minimum spacing of 360' between unsignalized access drives for a town highway with a speed limit of 45 mph. The spacing between all of the driveways and intersections is below this minimum recommendation. The high density of drives and limited spacing contributes to unsafe conditions for through traffic as well as traffic entering from the access drives.

Figure 8: View for traffic entering from Taproot Farm Rd. Intersection – September 2012

- **Mid to Long Term:** Apply access management practices to reduce quantity of access drives and consider the relocation of the Boutin Road intersection.
- **Other Considerations:** Undersized culverts and inadequate roadside drainage culvert and swale maintenance mm 0.825-0.9. VT minimum culvert size for road crossing = 18". Existing culvert size mm 1.0 = 15"

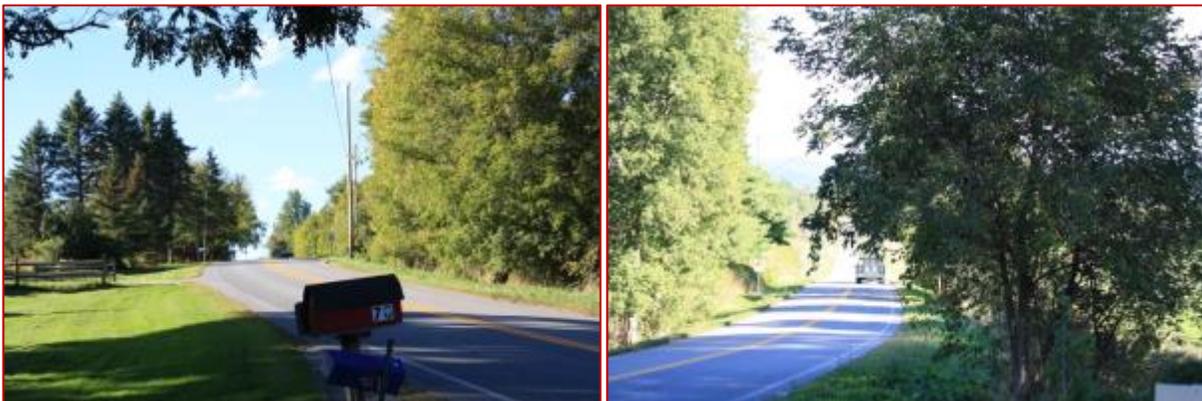
Figure 9: View for traffic entering from Boutin Rd. Intersection – September 2012

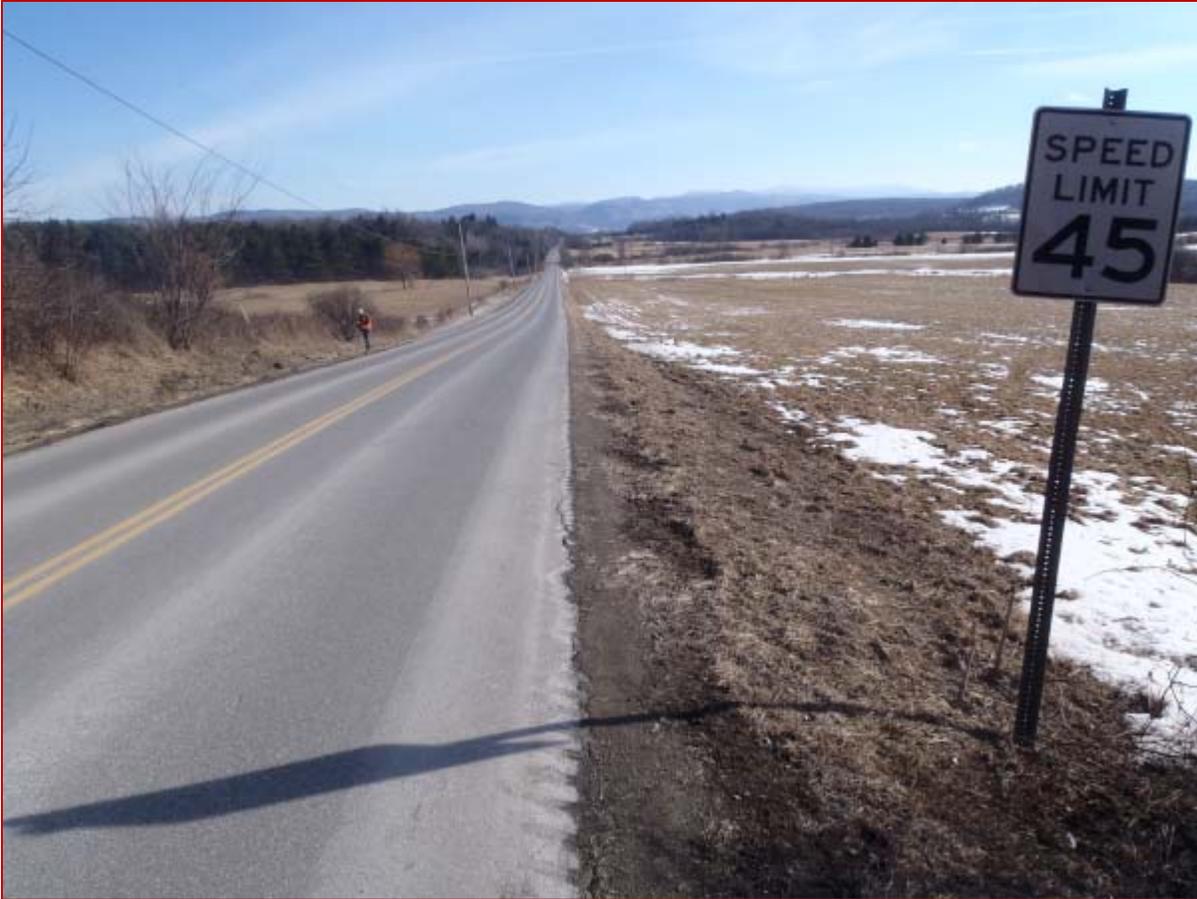
*Figure 10: View straight section of road for westbound traffic approaching Boutin Rd.
EB – February 2014*

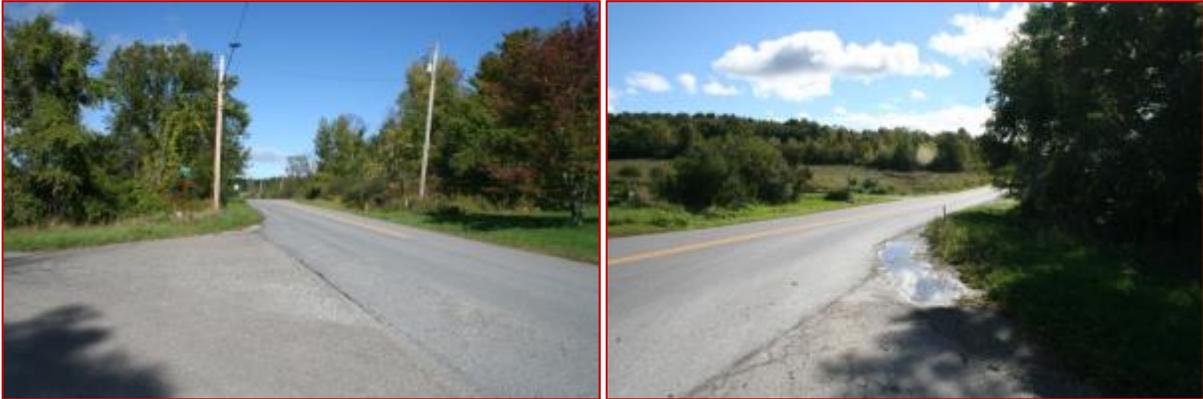
Recommended Minimum (45 mph)	Available Sight Distance
Intersection Sight Distance O-Neil Rd	500 ft	385 ft
Stopping Sight Distance Eastbound	360 ft	300 ft

Eastbound sign placement is too close to the intersection (W2-2) minimum distance is 800'; the distance provided is 300'. This section of the study corridor also can potentially experience higher speeds in the eastbound direction due to an approximately 1.0 mile straight section of road with limited peripheral obstructions resulting in an increased inferred design speed.

Figure 11: View for traffic entering from O'Neil Rd. Intersection – September 2012

- **Observation:** Inadequate sight distance for design speed due to vertical curve.
- **Immediate Action:** Relocate the existing advanced intersection warning sign (W2-2R) 500' west for eastbound traffic. Erect an advanced intersection warning sign (W2-2L) for westbound traffic 800' from the intersection. Add advisory speed placard to intersection warning signs for a speed of 30 mph (W13-1P).
- **Mid to Long Term:** Relocate the O'Neil Road intersection to the crest of the vertical curve to improve sight distance in both directions. Otherwise, consider lowering speed limit to 35 mph for this stretch of corridor. Adjust all signs as necessary.

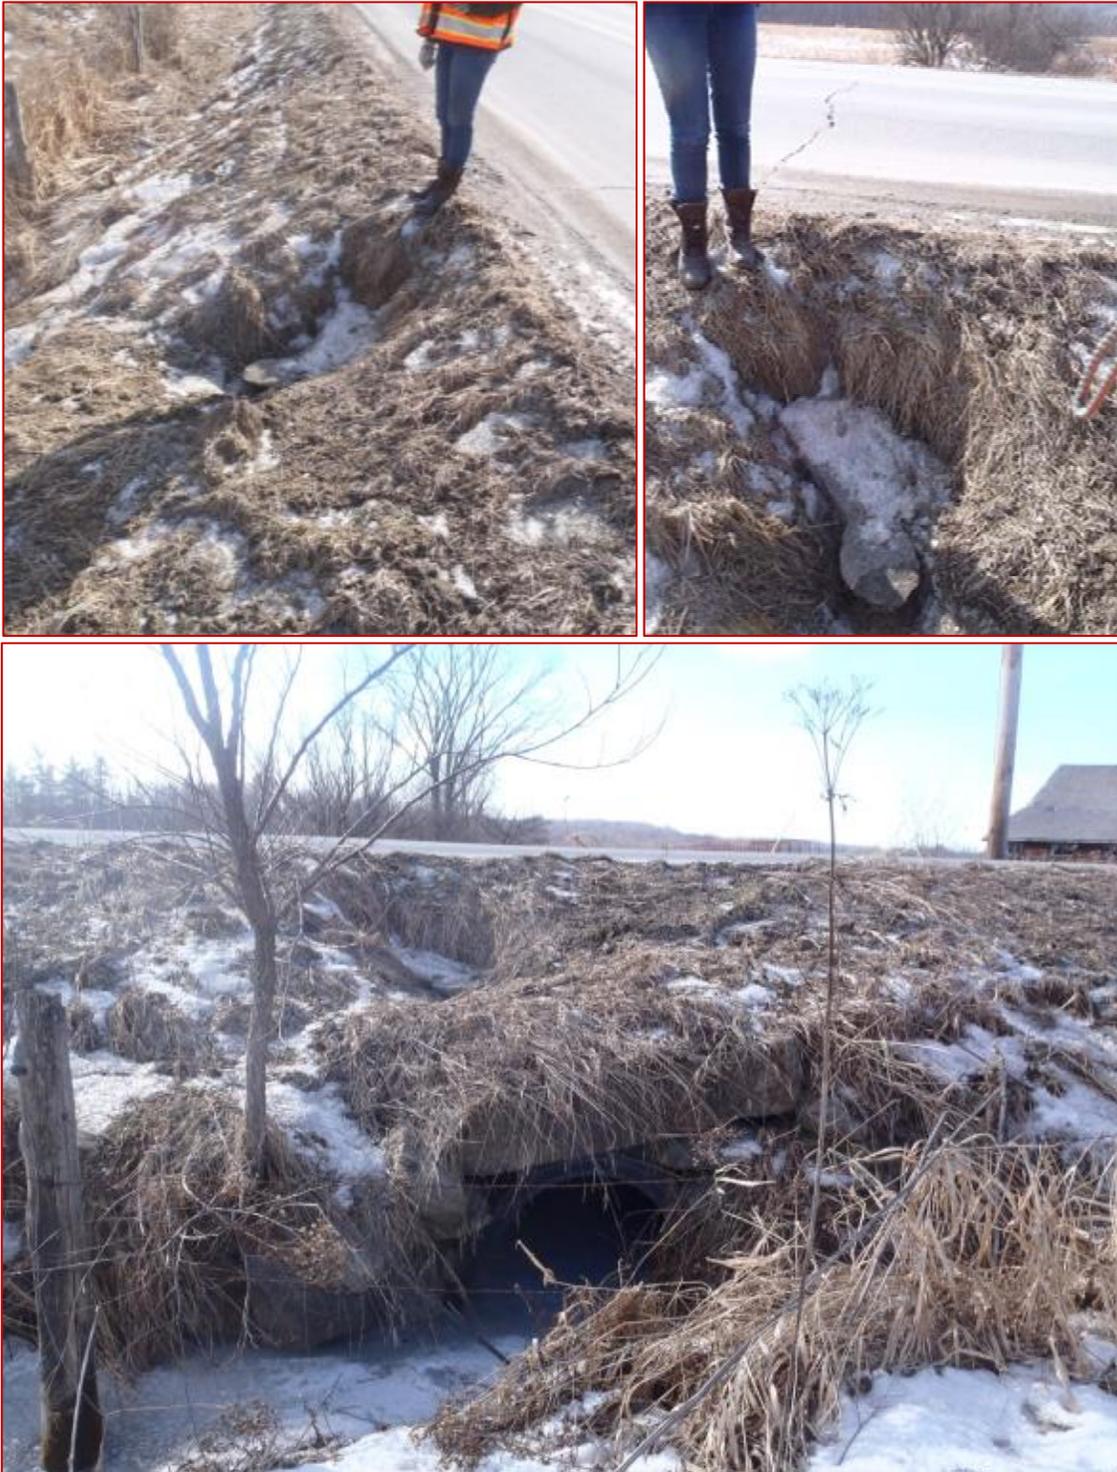
- **Observation:** Deteriorating road crossing culvert and multiple clogged driveway culverts. The deteriorating culvert backfill has caused a sinkhole to form and improper bedding for the road crossing culvert has also allowed for settling and road and shoulder deterioration. Steep side slopes create a potential hazard.

Figure 12: Deteriorating road crossing culvert (36" HDPE) near O'Neil Rd. February 2014

- **Short-Term Action:** Reshape westbound drainage ditch to improve drainage. Construct guardrail in key locations.
- **Mid to Long Term:** Replace bedding material around 36" HDPE culvert to prevent further settling and deterioration of the surface course. Construct a new concrete headwall to prevent future degradation of the culvert inlet.

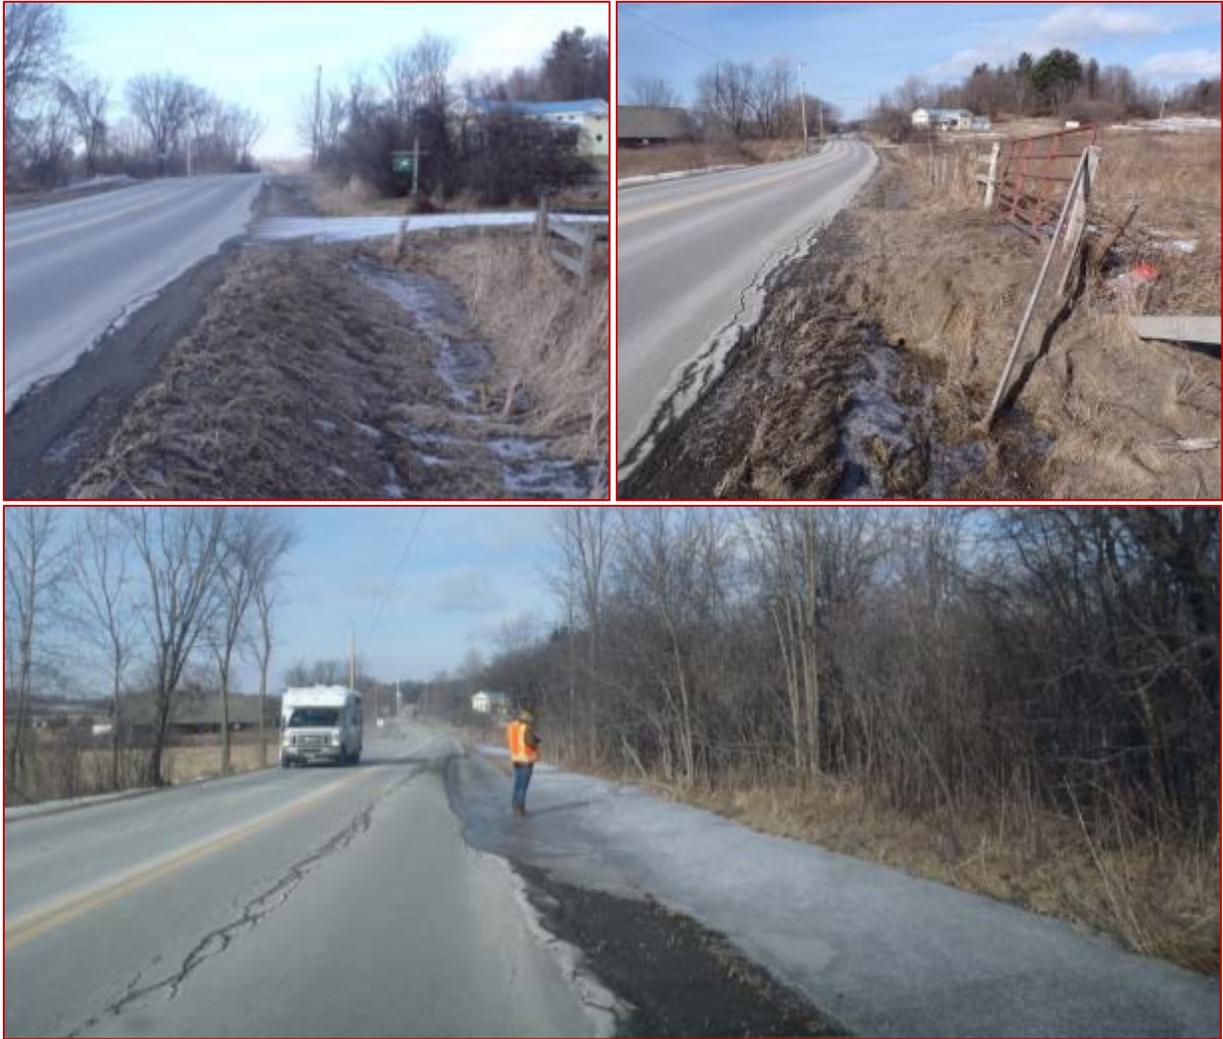
Poor drainage through the undersized and clogged driveway culverts for driveways accessing the corridor on the westbound lane has resulted in ponding on the traveled way. Existing culvert sizes (mm 1.80)= 12", VT minimum = 15". These culverts, draining to the road crossing culvert further east are not properly draining

and the ponding runoff freezes during winter months and create unsafe conditions. Shoulder degradation is also a result of poor drainage through this section of the study corridor. Saturated conditions during freeze-thaw events can disrupt the subbase and result in surface course deterioration. See photos below of ice on road at mm 1.83 to mm 1.85 (WB).

Figure 13: Other drainage observations westbound approach to O'Neil Rd. February 2014

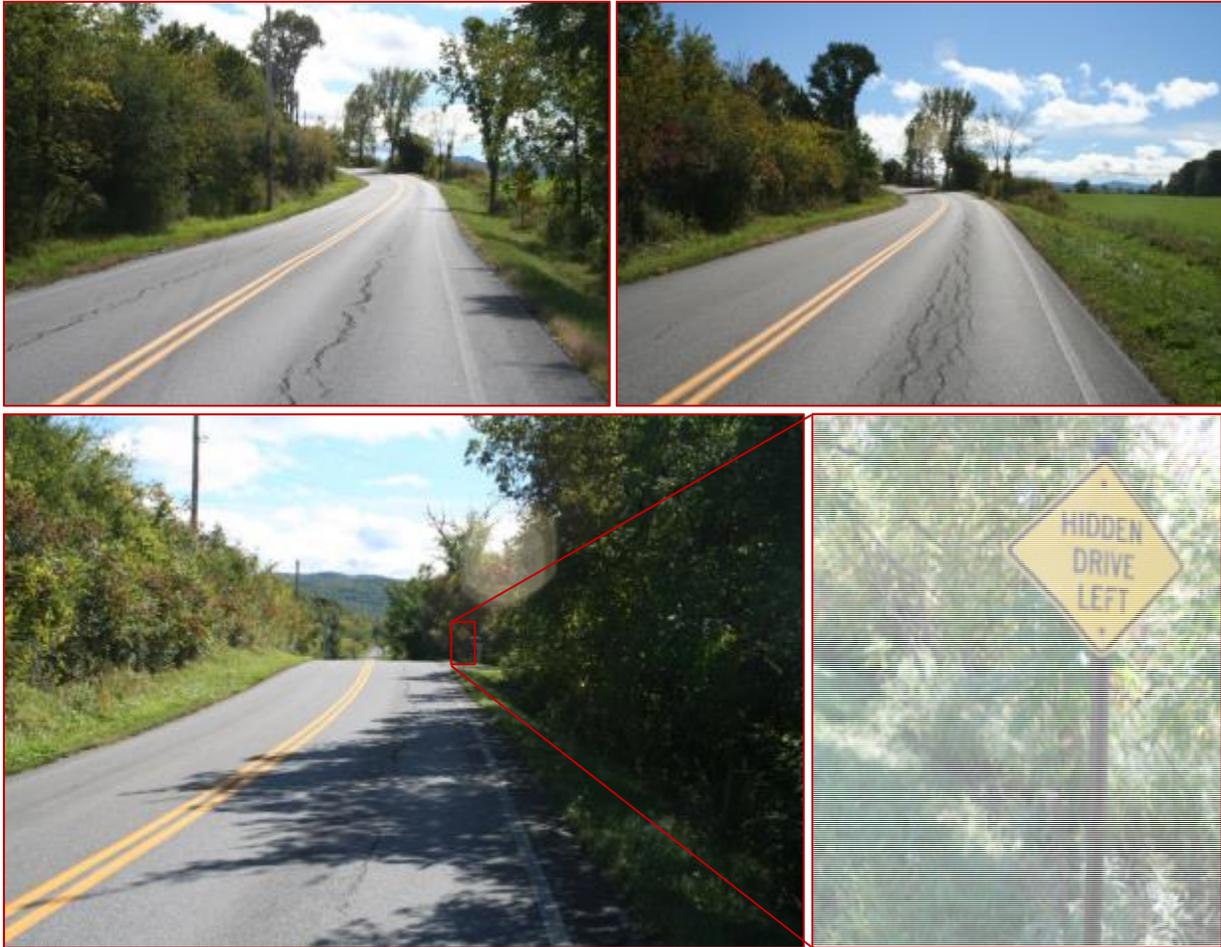
This section of the study corridor does not contain adequate signage to warn operators of the unsafe conditions. There is an old, deteriorating hidden drive sign in the eastbound direction.

Figure 14: Inadequate signage through vertical and horizontal curve. EB - September 2012

- **Immediate Action:** Install a culvert under driveway #786 using minimum 15" HDPE to improve drainage and address ponding. Clear vegetation as indicated in section **Error! Reference source not found.** part **Error! Reference source not found.**

- **Short-Term Action:** Reshape existing drainage ditches for both directions to improve drainage. Consider lowering speed limit to 35 mph for this stretch of corridor. Adjust all signs as appropriate. Advanced warning curve speed limit advisory placards should be reduced to 25mph in both directions. This cannot be achieved without first reducing the speed limit, however based on the observed sight distances, the existing signs indicate an inappropriately high advisory speed for this curve.

- **Mid to Long Term:** Replace existing 15" CMP road culvert with minimum 18" HDPE culvert. Cut back existing bank offset from the WB lane to improve sight distance through the horizontal curve.

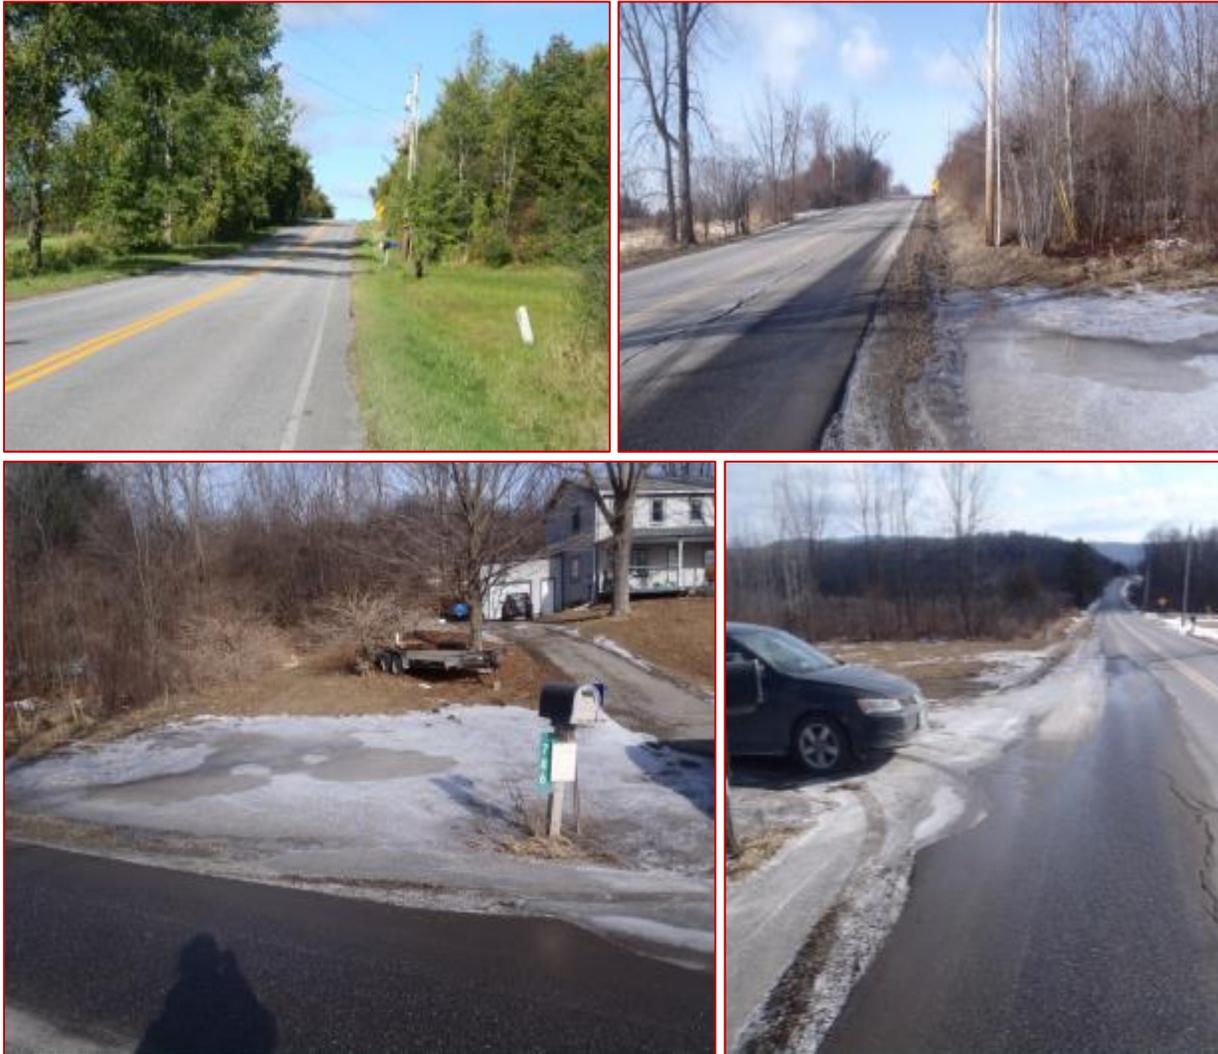
In addition to the limited visibility, this section of the study corridor contains narrow shoulders with close proximity to ledge and multiple locations are experiencing shoulder degradation. Poor drainage has eroded the surface course from the shoulder and contributed to degradation of the pavement. An undersized road crossing culvert at mm 2.05 (15" vs VT min. of 18") could be the cause for poor drainage. In the westbound approach towards the horizontal and vertical curves, there is a driveway with no culvert (Driveway #786 WB) which does not drain properly. Ponding occurs which freezes during winter conditions, resulting in unsafe conditions for through traffic. See photos below for documentation of these observations.

*Figure 15: Inadequate drainage through vertical and horizontal curve
WB – September 2012(top left), February 2014 (top right, bottom)*

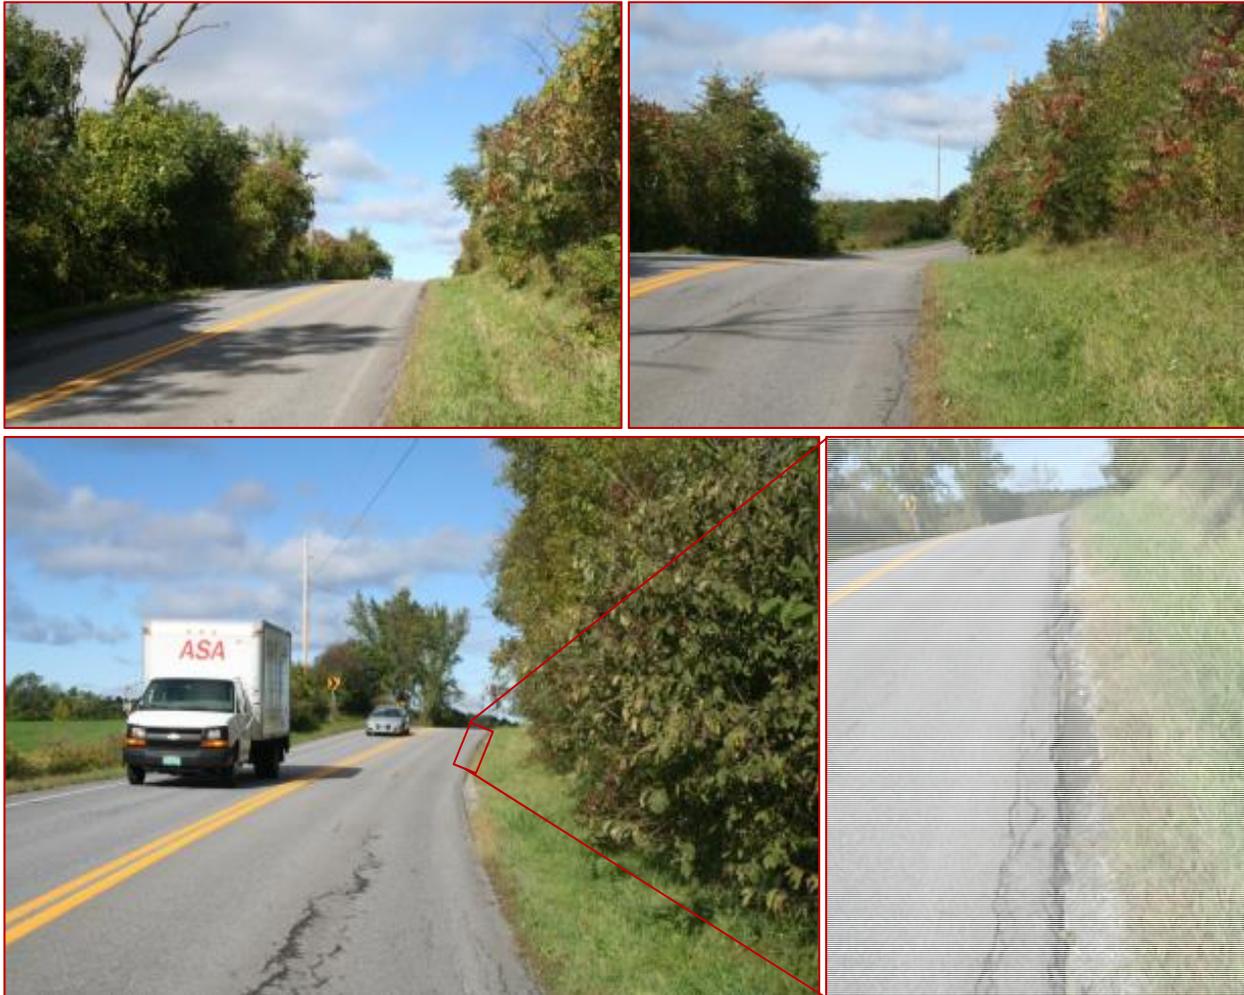
*Figure 16: Poor visibility through vertical and horizontal curve and shoulder degradation
WB- September 2012*

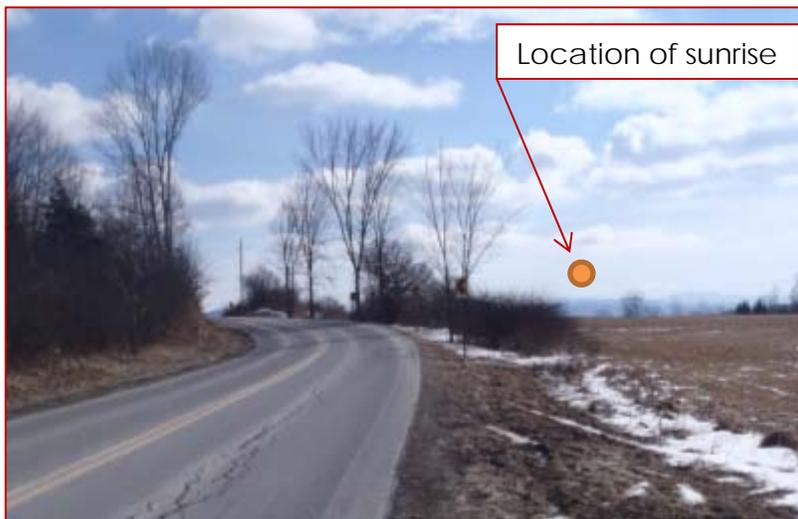
morning hours due to direct sunlight. Signs are difficult to see due to bright background and overgrown vegetation. The vertical and horizontal curve reduces the ability for vehicle operators to identify traffic entering from the driveway access points on both the eastbound and westbound sides. The advanced warning curve sign with advisory speed placard was changed from 30 mph to 35 mph after recommendations from the 2007 safety report by Vermont Local Roads.

*Figure 17: Blinding morning sunlight reducing visibility
EB - February 2014*

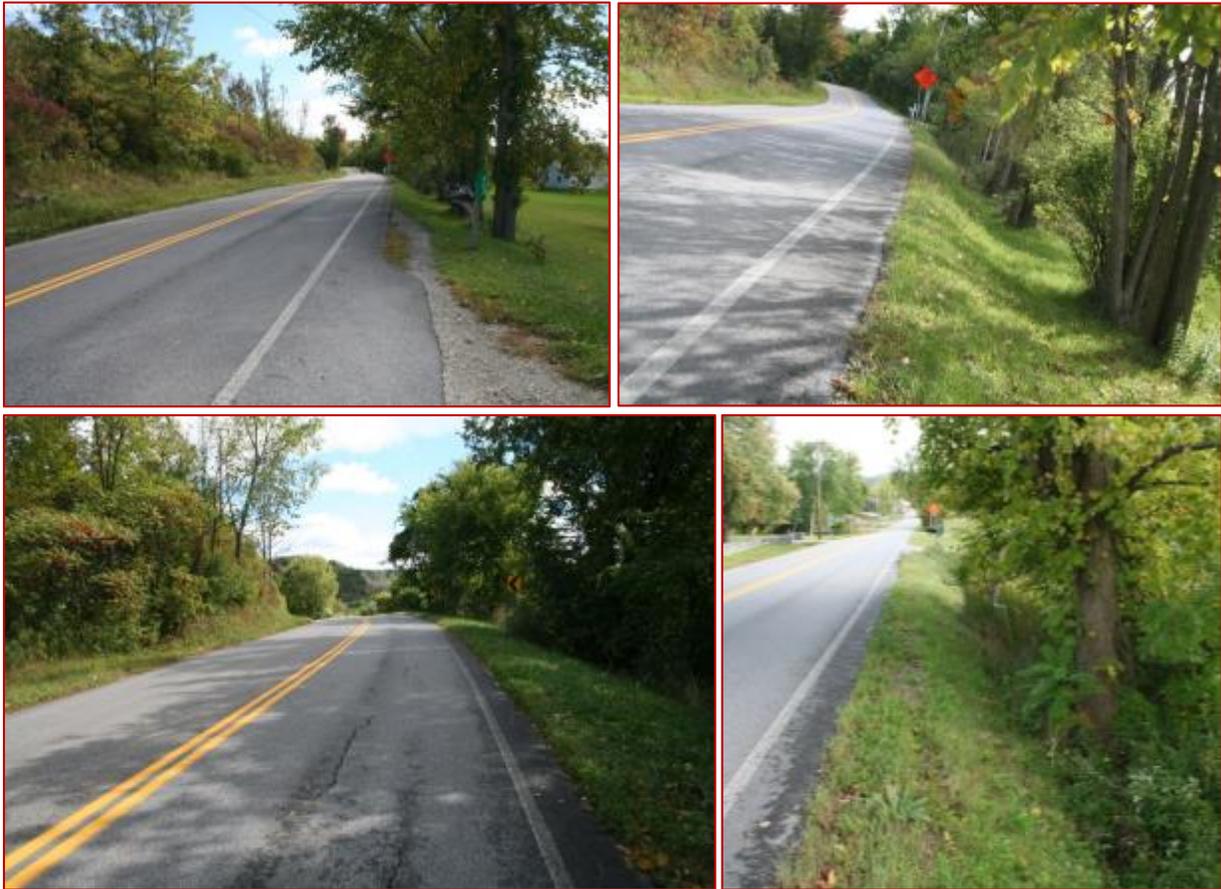
In addition to poor visibility, this section of the study corridor has very narrow shoulders and poor drainage. Inadequate drainage has resulted in scouring contributing to the degradation of the shoulder surface course. There is also a steep bank in the shoulder of the westbound bank that is at risk of erosion and reduces visibility. Steep side slopes drop off from the shoulder for eastbound traffic increasing the consequence of off-road crashes.

Figure 18: Low sign visibility and steep side slopes. EB – September 2012

- **Observation:** Inadequate sight distance for design speed due to horizontal and vertical curve. This section of the study corridor has a posted speed limit of 35 mph beginning at mm 2.78 in the eastbound direction.
- **Immediate Action:** Clear limiting vegetation.
- **Short-Term Action:** Advanced warning curve speed limit advisory placards should be reduced to 30 mph in both directions. Reshape existing drainage ditches for westbound shoulder to improve drainage
- **Mid to Long Term:** Cut back existing bank offset from the WB lane to improve sight distance through the horizontal curve. Install guardrail in key locations.

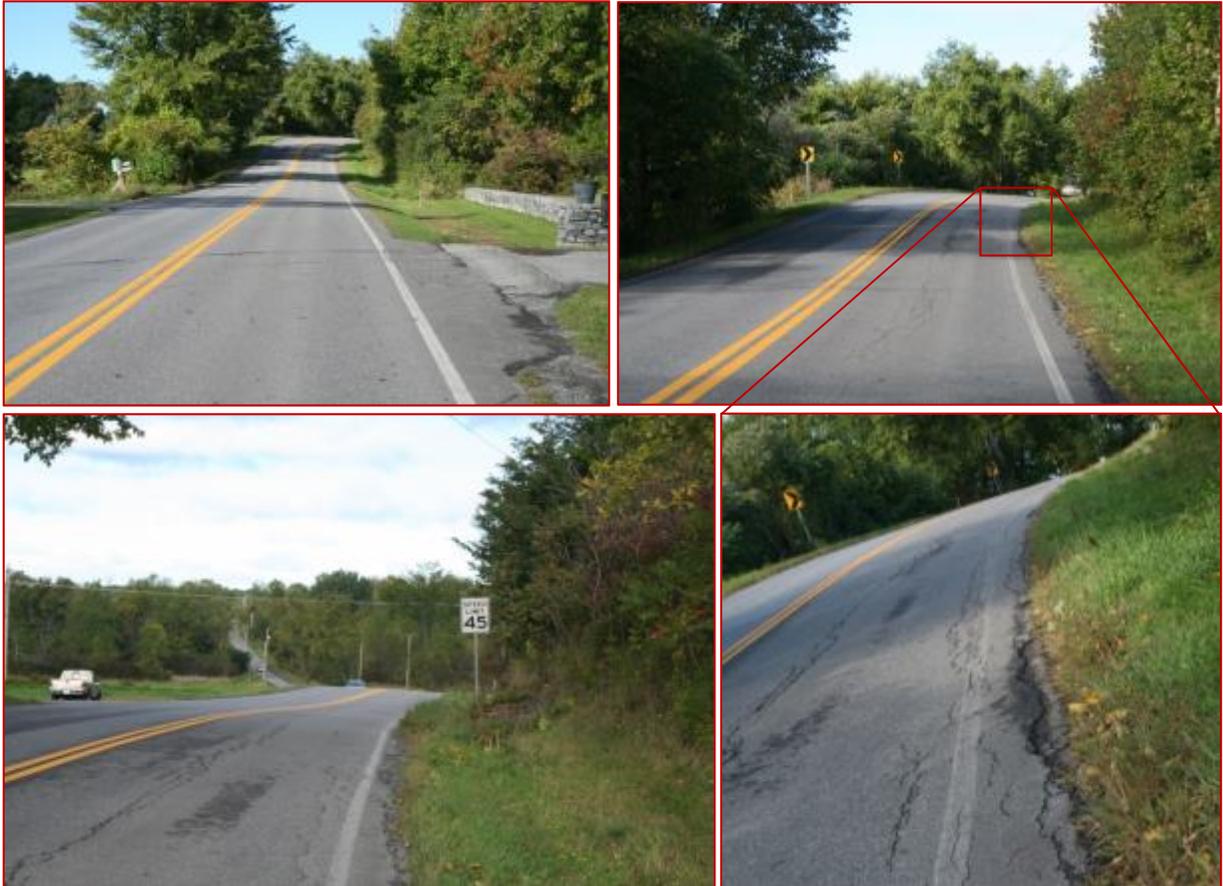
Figure 19: Low sign visibility and shoulder degradation. WB – September 2012
