HINESBURG SIDEWALK SCOPING STUDY

DECEMBER 2014

PREPARED FOR:
TOWN OF HINESBURG, VT

SUBMITTED BY:
RSG

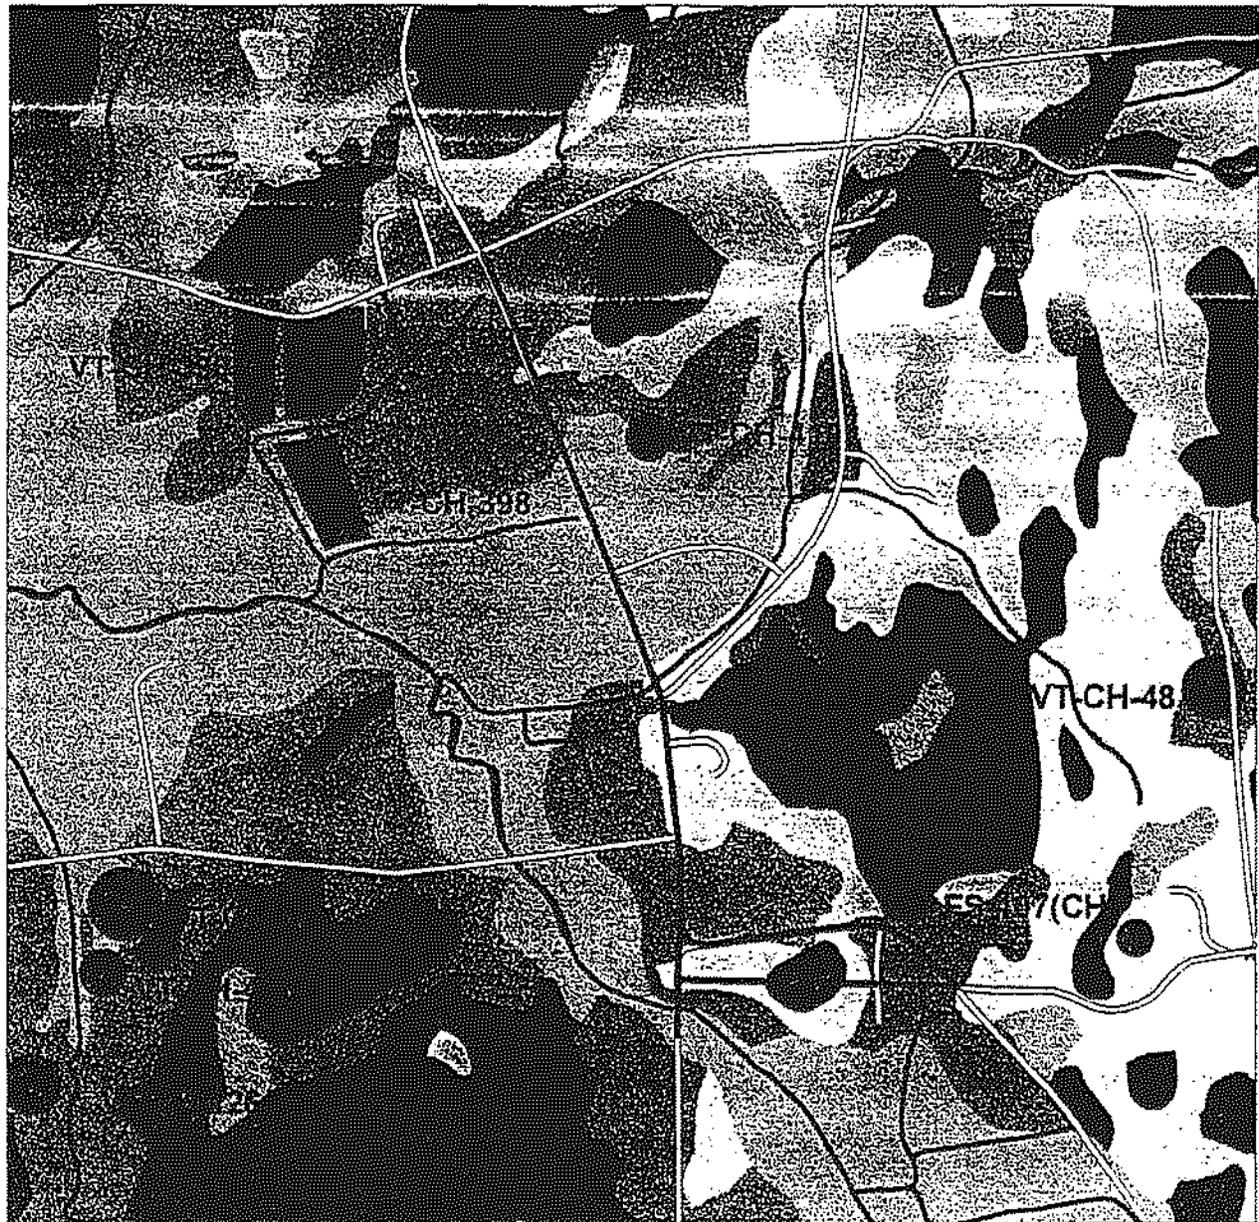
Figure 2: Reconstructed forest communities in the vicinity of the VT Route 116 project corridor in Hinesburg, Chittenden County, Vermont.

Oak-Ash-Hickory -> Maple-Ash-Beech
