SHELBURNE FALLS ROAD SAFETY STUDY

TCE# 2012005-1
HINESBURG, VERMONT

Date:
September 29, 2014

Prepared For:
Town of Hinesburg

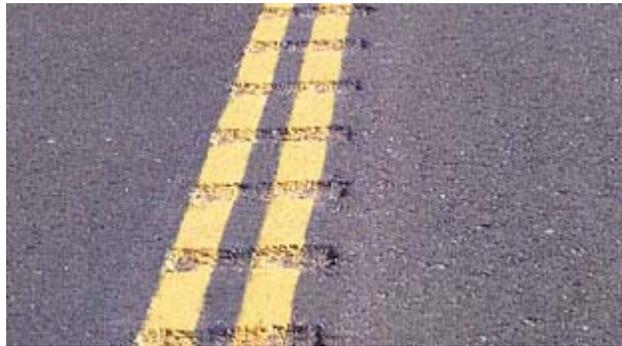
Figure 20: Centerline Rumble Strip

Observation: Inattentive and inexperienced drivers frequently use this corridor, which can lead to vehicles inadvertently crossing the center line and lead to serious head on collisions.
